REPORT OF INVESTIGATION  
(UNDERGROUND COAL MINE)

FATAL BUMP ACCIDENT

Olga Mine (ID No. 46-01407)  
Olga Coal Company  
Coalwood, McDowell County, West Virginia

December 8, 1978

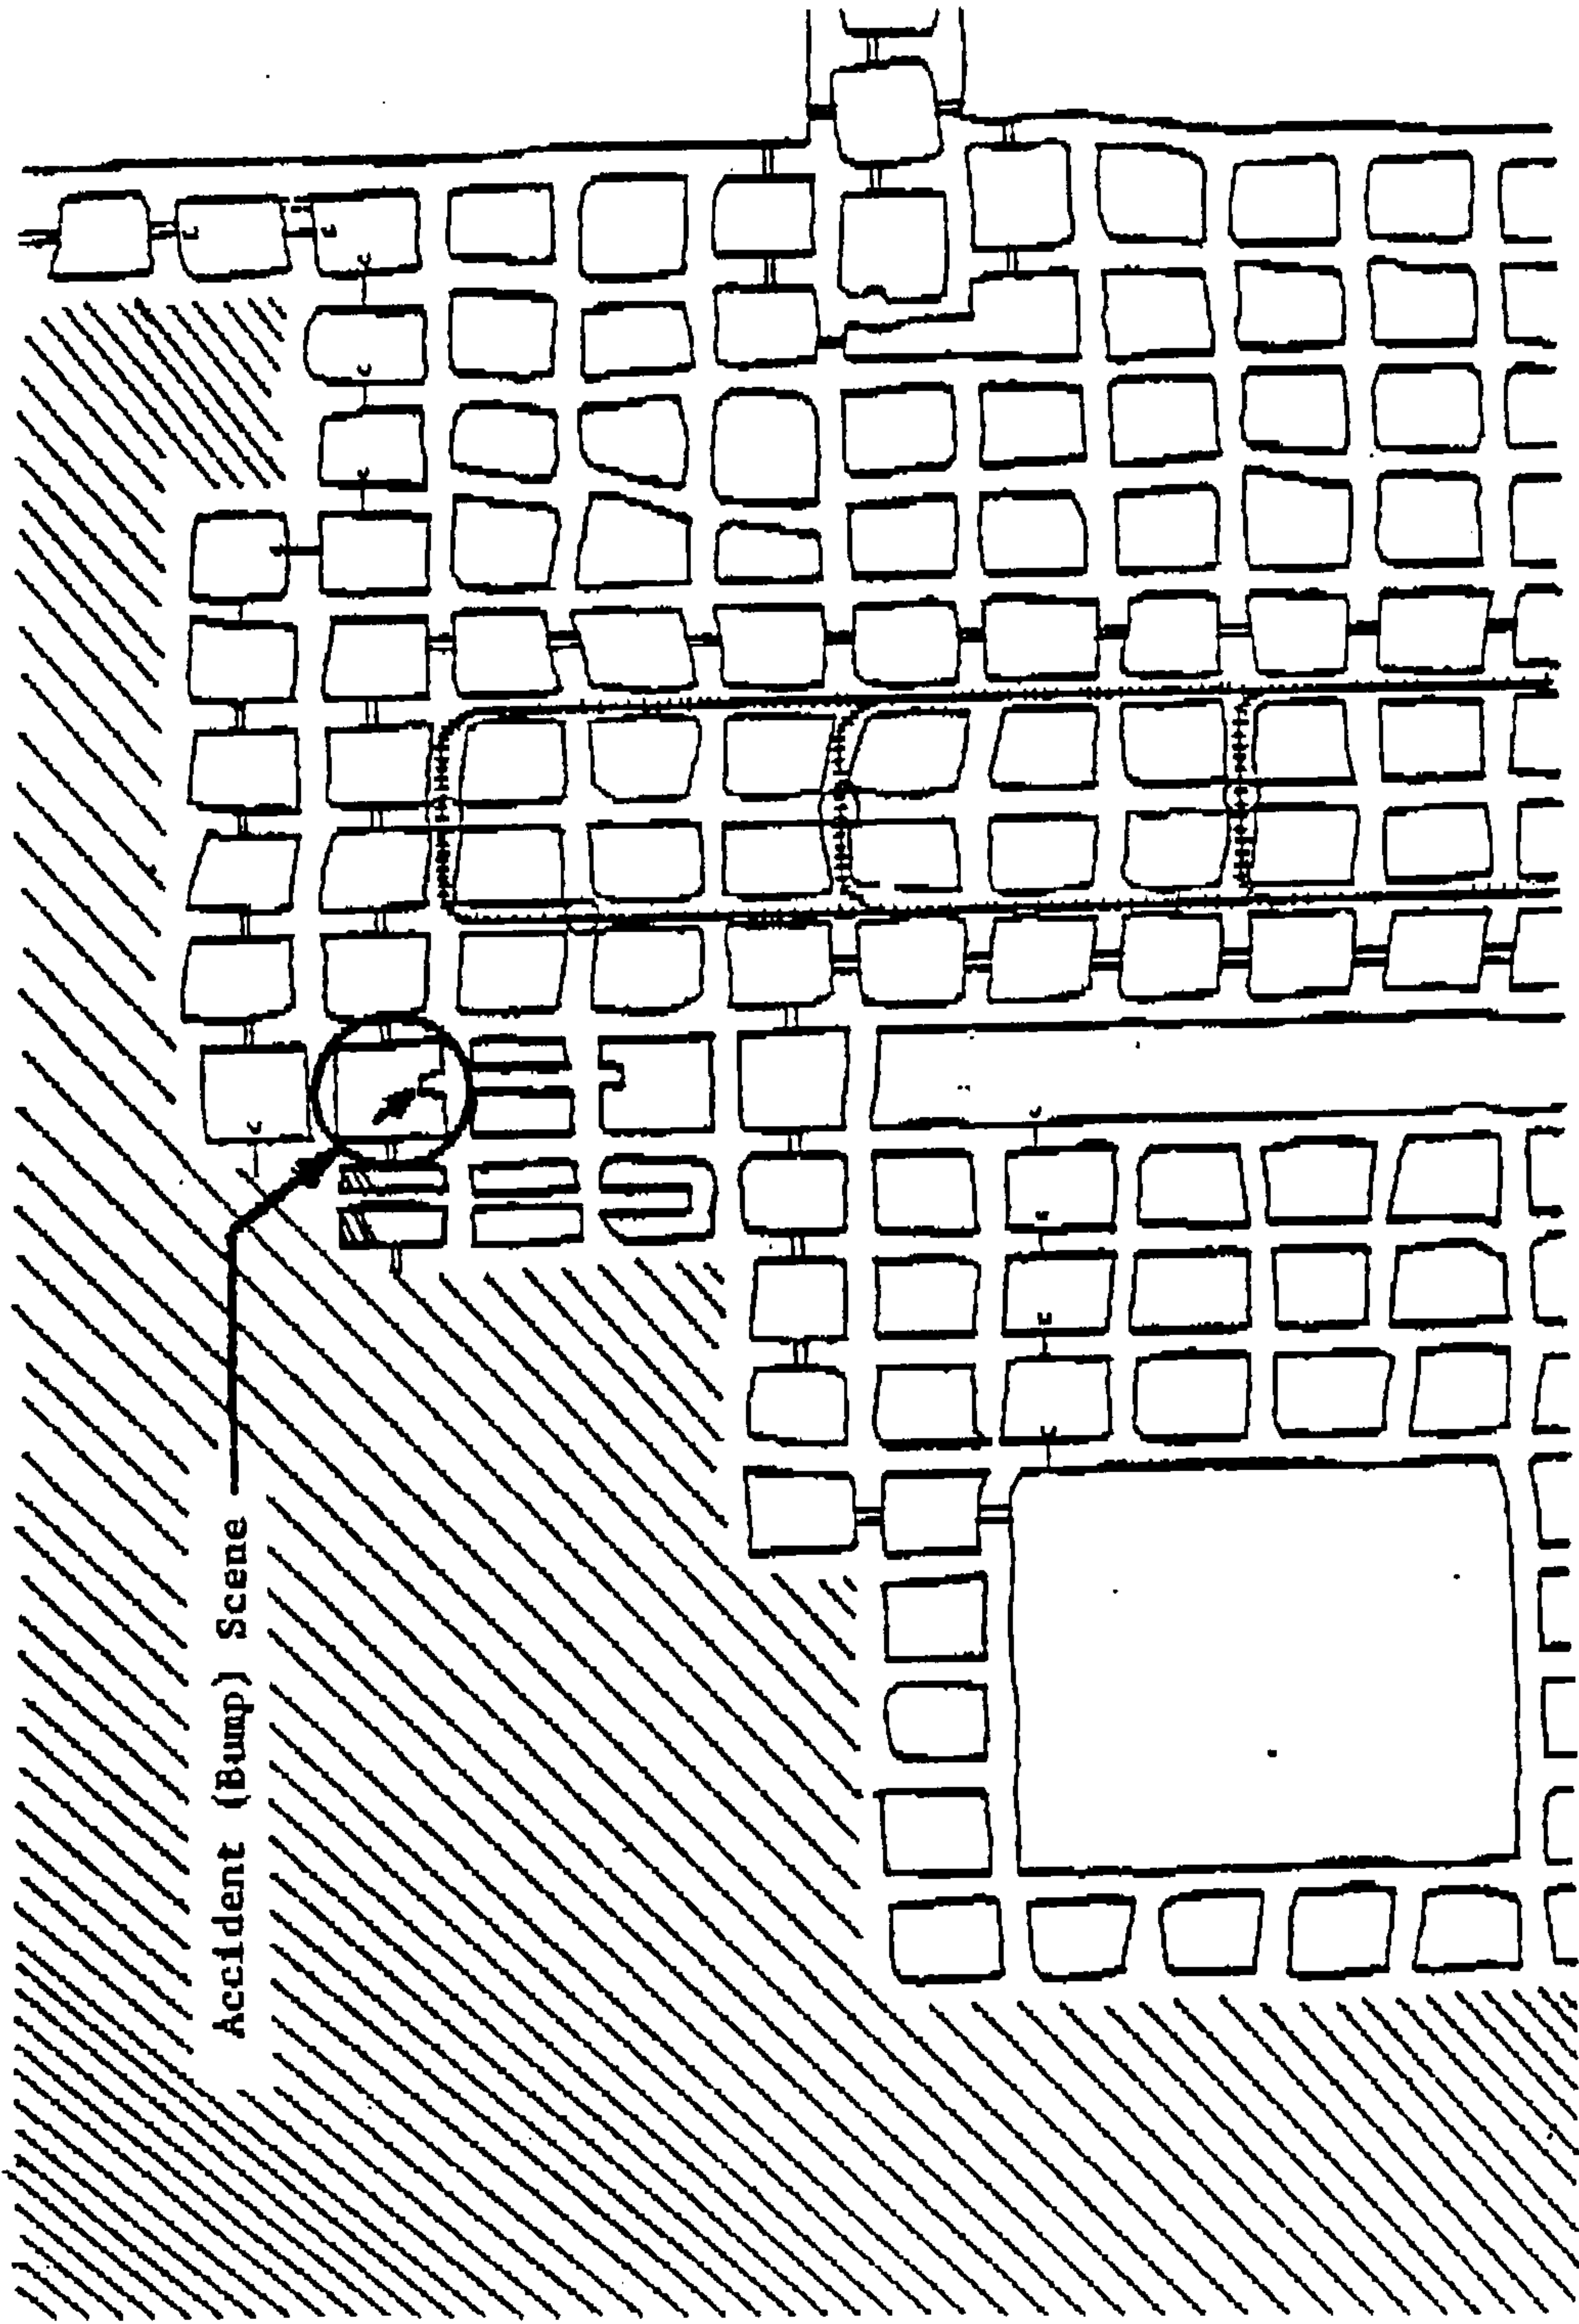
Accident (Bump) Scene

1. The bump occurred in pillar No. 15 (See Sketch) that was approximately 82' x 67' x 5' in size. Forces from the bump scattered very

little coal around the periphery of the pillar. At the particular time of the bump, a split was being advanced through the pillar with a continuous mining machine. The split had been advanced to a depth of about 15 feet when the bump occurred. The width of the split was 20 feet. According to mine management, the pillar was being split to reduce its size and thereby reduce the bump potential. However, observations at the accident scene revealed that there was a pillar inby No. 15 pillar that was inaccessible because of the heaved mine floor and a split through pillar No. 15 would have provided access to the inby pillar.

2. Further observation in the accident area revealed that pillar No. 15 (bump pillar) was located at the junction of two pillar lines that intersected at right angles (See Sketch). The mining practices and procedures in the section had allowed pillar No. 15 to remain full size until the adjacent pillar lines had approached the immediate area of pillar No. 15 before mine management started to reduce the pillar size. This practice of splitting pillars in close proximity to a pillar line results in abnormal pressures and subsequent bumps when the coalbed is between a strong roof and floor, such as was the case in particular. Examination of the mine map with regard to the elevations in the area indicated there was approximately 1,485 feet of earth cover, with 200 plus feet of massive sandstone roof directly over the coalbed. Furthermore, the mine floor was composed of shale which averaged 2 feet in thickness, underlain by massive sandstone of an undetermined thickness.
